# **Planned Preventative Maintenance Survey Report**

## **London Borough of Hillingdon**

Harlyn Primary School  
Tolcarne Drive  
Pinner  
HA5 2DR

Concertus  
August 2023

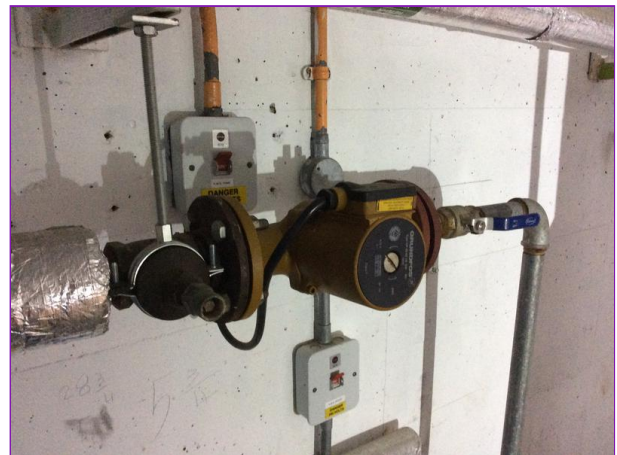
Photo 370 - East block original school HWS circ pump

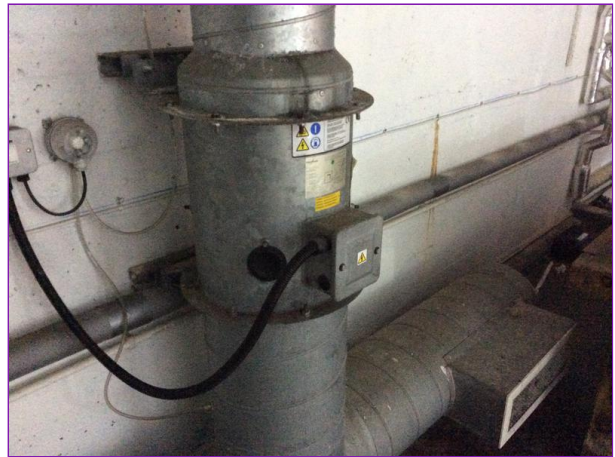
Photo 372 - East block original school plantroom  
vent fan

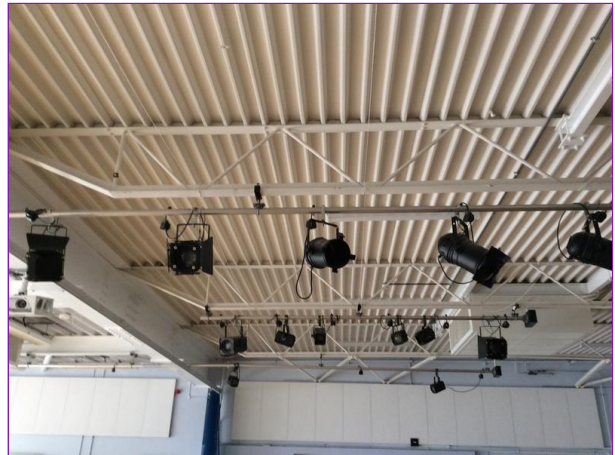
| Photo Location | Element | Issue | Action | Cost Estimate | Comments | Photo |
|---|---|---|---|---|---|---|
| GND52 hall | Electrical Services/5.8 .<br>Electrical Installations/<br>5.8.4. Specialist Lighting<br>Installations | Obsolete | Replace | £9,600 | D1 | |

Photo 377 - Stage lighting

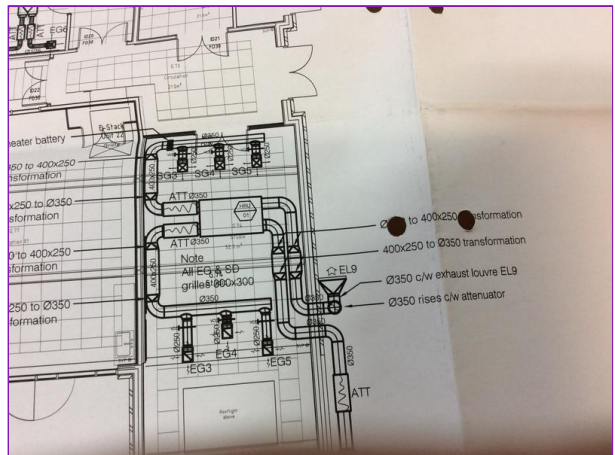
Photo 387 - GND 30 HRU ventilation

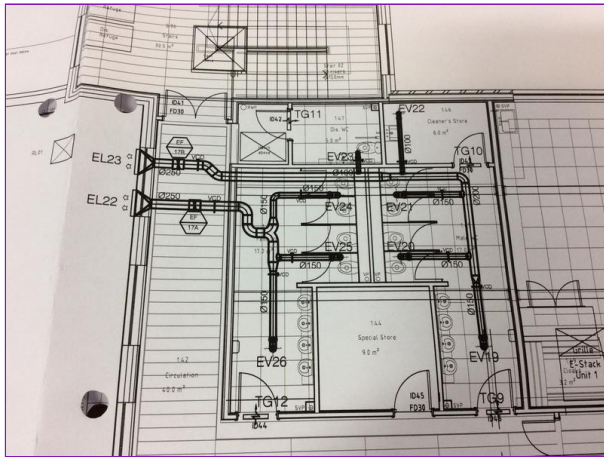
Photo 394 - Location of FST extract fan

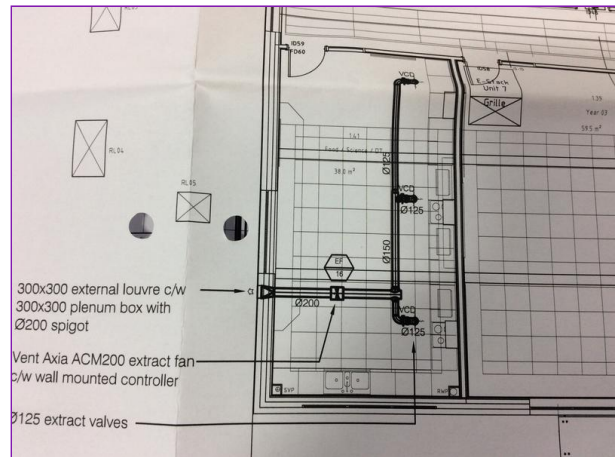
Photo 395 - FST 14 ventilation

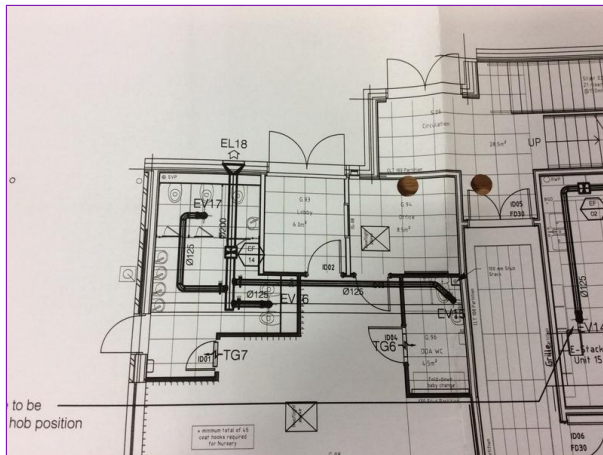
Photo 396 - GND1 ventilation

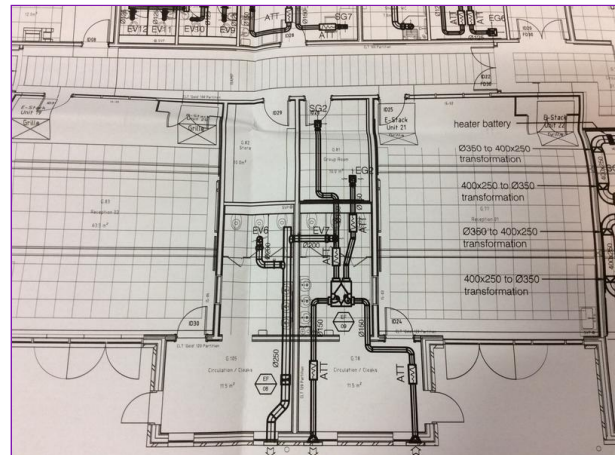
Photo 397 - GDD33 & 34 ventilation

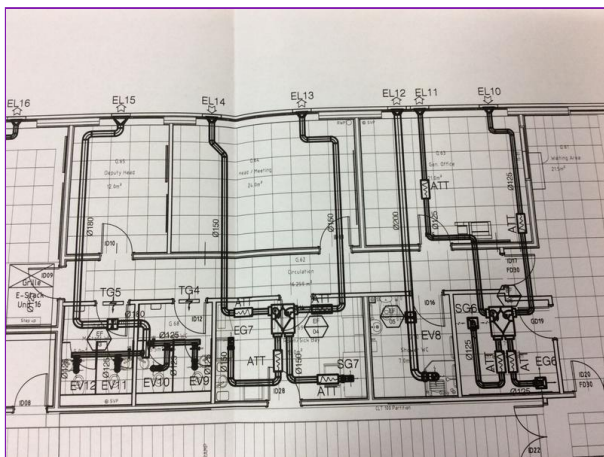
Photo 398 - GND16-20 extract fans
