# Report Document

Project Name: Harlyn Primary School  
Project Address: Tolcarne Drive  
London  
HA5 2DR

## Roof Survey Report & Recommendations

Roof area covered by this report: Roof A , Roof B, Roof C, Roof D, Roof E, Roof F, Roof G, Roof H, Roof I, Roof J, Roof K

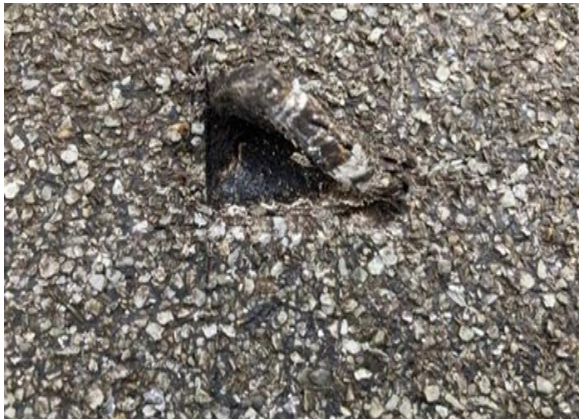
##### Core Sample – Roof A, F, G & I

Deck – Screeded concrete  
Waterproofing – RBM Felt

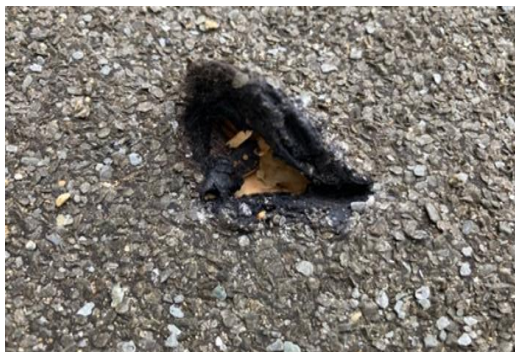
##### Core Sample – Roof B & C

Deck – Plywood  
Waterproofing – RBM Felt

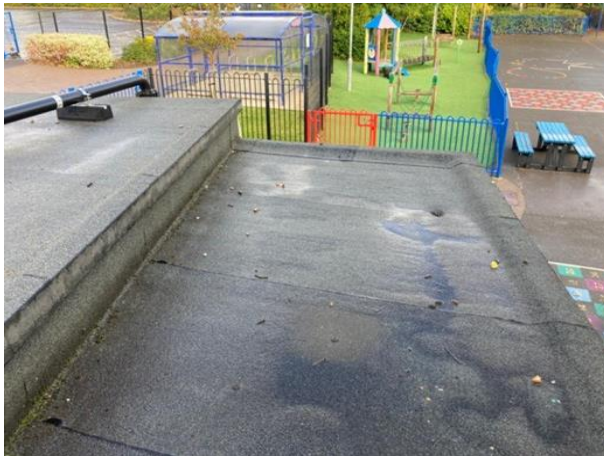
Overview of the roof area

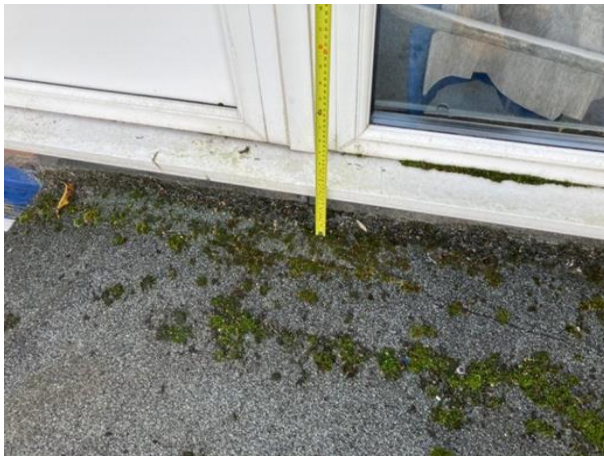
Low window cill is present on roof A circa 120mm above the roof surface.

**Window cill circa 120mm above the roof surface**

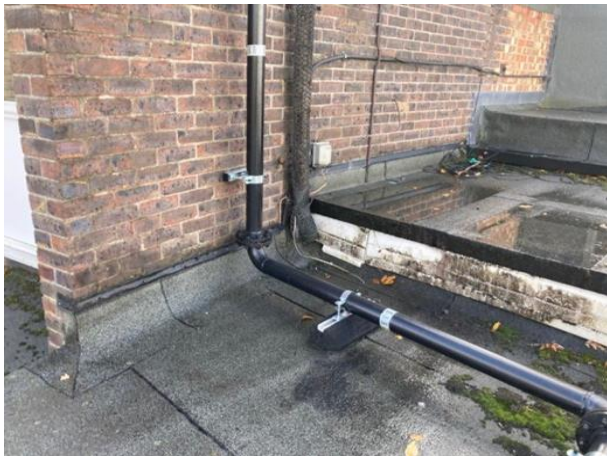
**Overview of Roof B**  
**Pipe work with support present on the roof**

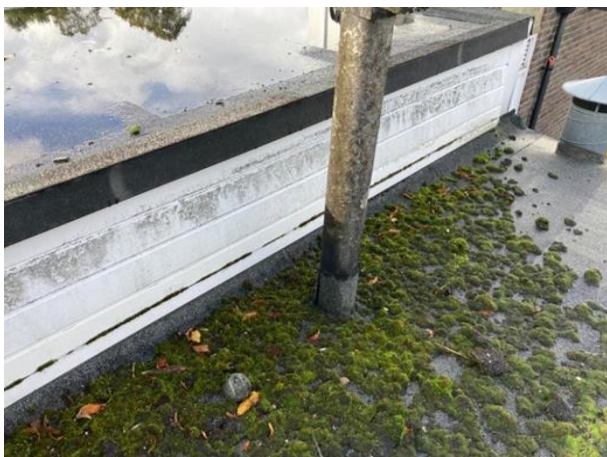
- **Drainage**  
Visually all roofs have fair falls (visual estimate 1:100/110). Roofs A, B, D and I all drain through a drip edge into external gutter. Roof C drains onto roof A. Roof F drains onto roof E and then through a chute into a hopper. Roof G drains into an internal outlet. Furthermore, moss growth evident on roof B indicating poor falls on the roof.

**Moss growth present on the roof**

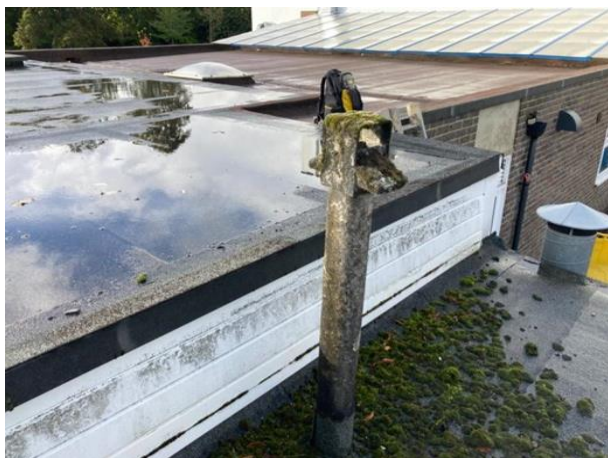
- **Penetration**  
Soil vent pipes present on roof B and I. Both soil vent pipes have poor detailing around them, which will allow water ingress in the near future.

Possible ACM soil vent pipe present on the roof.

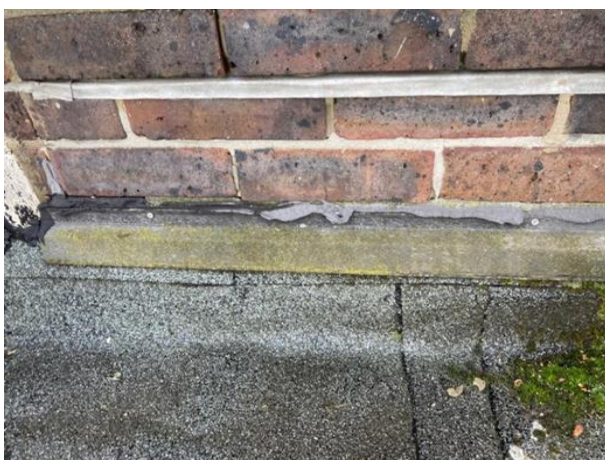
Mastic repair to the upstand indicating previous water ingress issues.

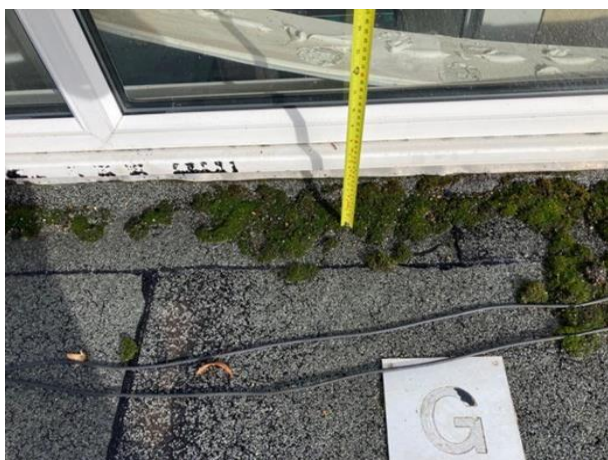
Low window cill present on roof G circa 130mm above roof surface.

Window cill circa 130mm above the roof surface

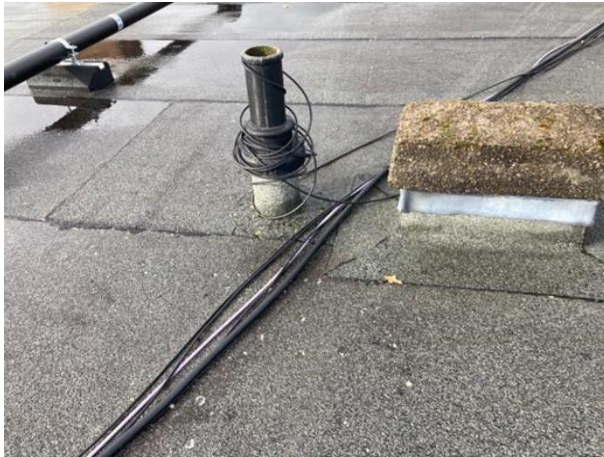
**Soil vent pipe present on the roof**

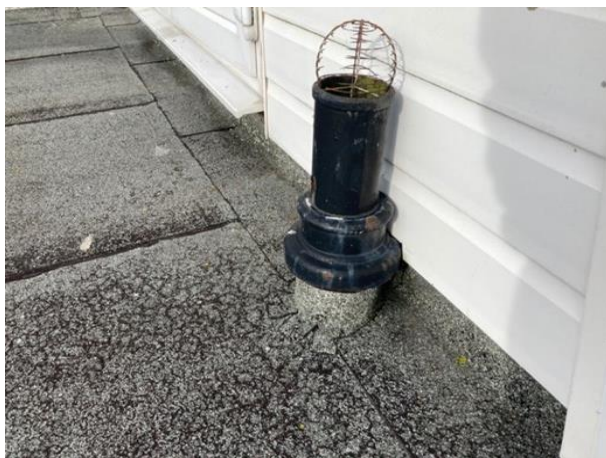
**Soil vent pipe near the UPVC cladding**

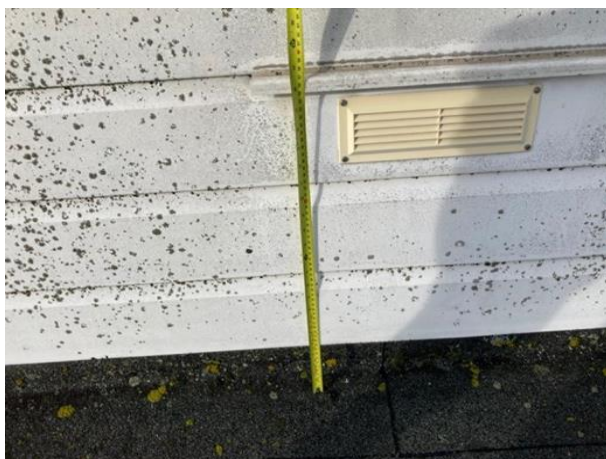
- **Skirtings**  
There are skirtings upstand present on roof C circa 200mm above the roof surface. Air vent present on roof I circa 450mm above the roof surface

**Wall cladding 120mm above the roof surface.  
Wall vent circa 450mm above the roof surface.**

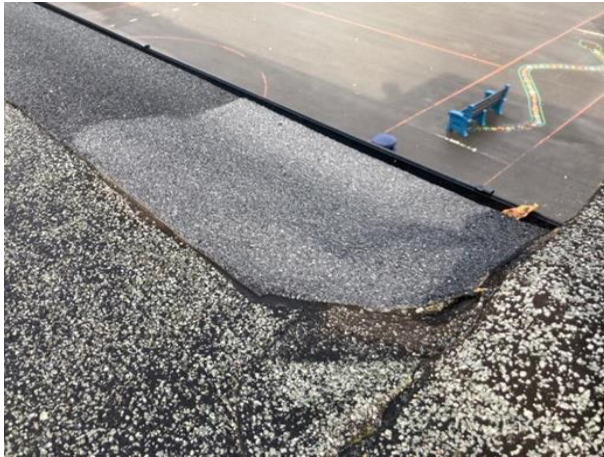
Evidence of previous repairs

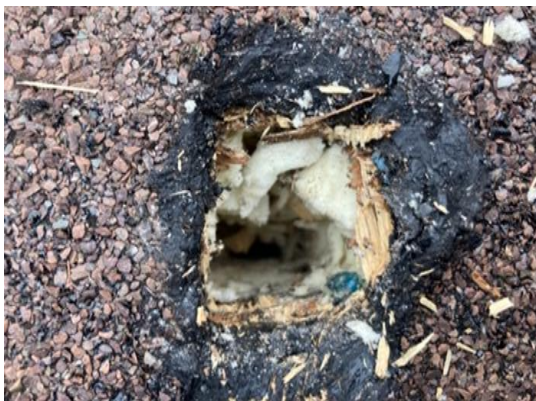
#### Core Sample – Roof E

Deck – Plywood  
Insulation – 200mm PUR  
Plywood sheeting  
Waterproofing – RBM

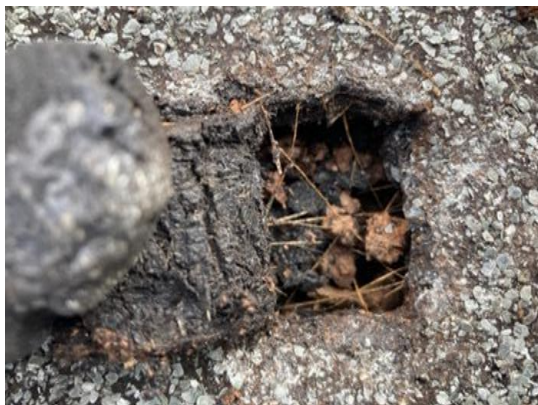
### Core Sample – Roof H

Deck – Plywood

Insulation – Cork 100mm

Waterproofing – RBM

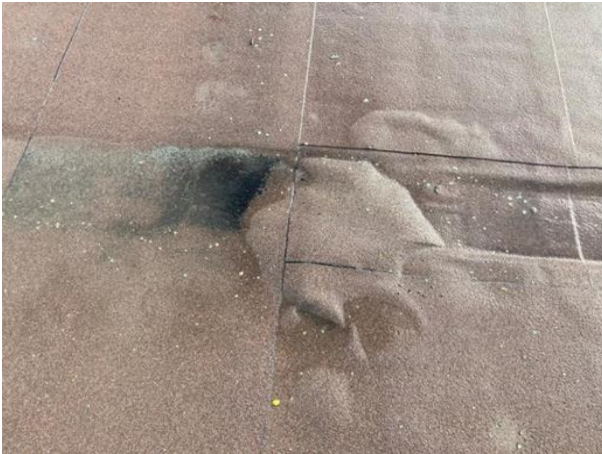
- **Main Area**  
Visually both roofs are in fair condition and have an existing RBM waterproofing. RBM suffers with UV degradation and lichen growth due to its age. There are some felt repairs evident on the roof area. Evidence of blistering also present on roof E which will cause further failures in the near future.
- **Perimeter**  
Roof E has a kerb around the perimeter with felt finished into a trim. Roof H has high parapet wall with felt finished into a trim.

**Evidence of blistering on the roof.**

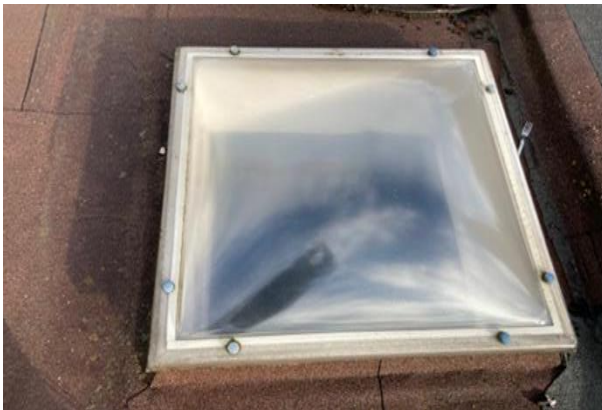
There is 1No. rooflight present on roof E. Rooflight suffers with UV degradation and requires replacement.

**Overview of the rooflight**

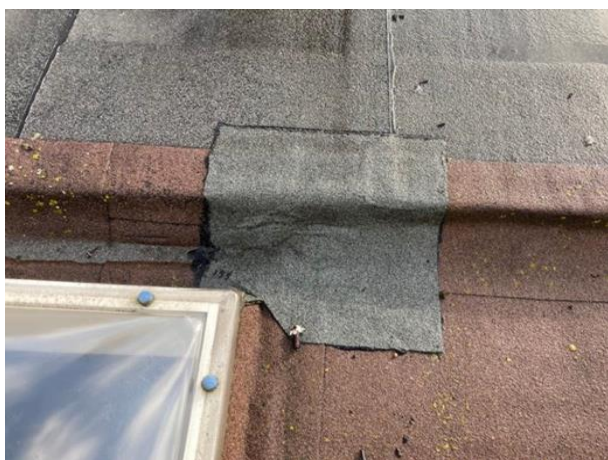
**Evidence of previous repairs**

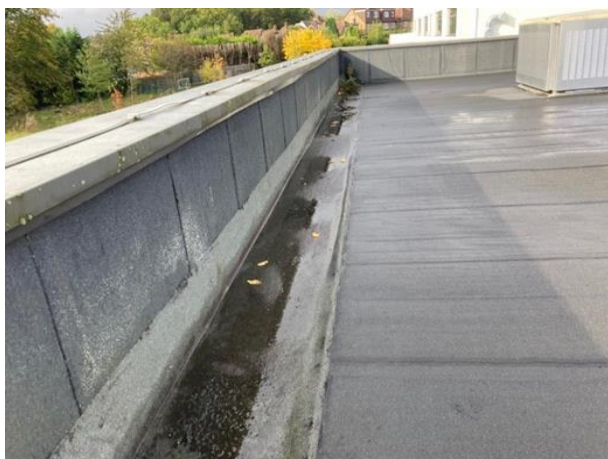
Visually falls on both roofs are fair. Roof E drains through internal gutter and into a hopper via a chute. Roof H also drains into internal gutter and into internal outlet. Ponding is evident inside the gutter and vegetation growth present indicating standing water from a blocked outlet.

**Overview of the gutter with evidence of ponding**

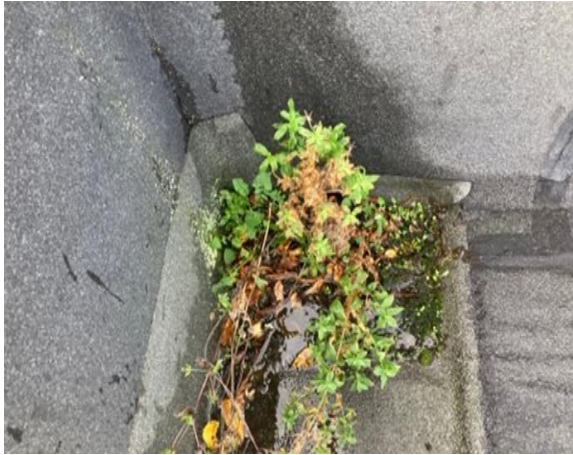
**Evidence of vegetation growth**

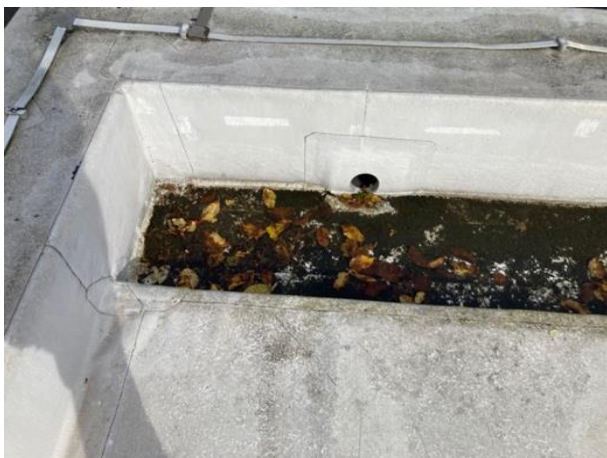
Falls on the roof are average (visually estimate 1:80). The water drains into internal gutter and into internal outlet. Evidence of moss growth is evident inside the gutter indicating that water is not reaching an outlet and just standing in the sump, thus supporting moss growth. Furthermore, this has created major ponding inside the gutter especially on roof K.

Internal gutter with evidence of ponding water

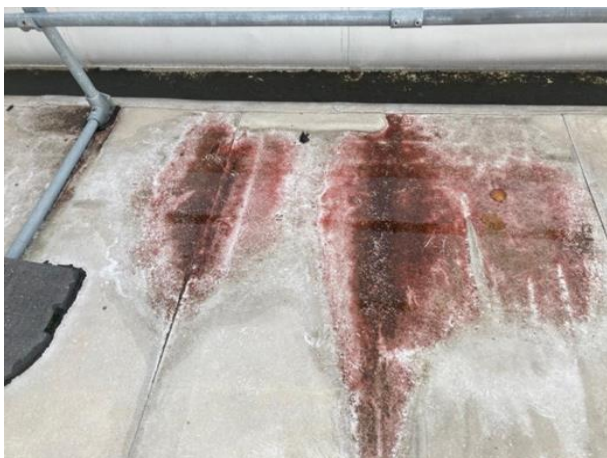
The roof is visually in poor condition and has an existing mech-fixed single ply waterproofing system. Signs of blisters and moss growth are evident on the roof indicating standing water, which will lead to further failures in the near future.

**Evidence of failing single ply**

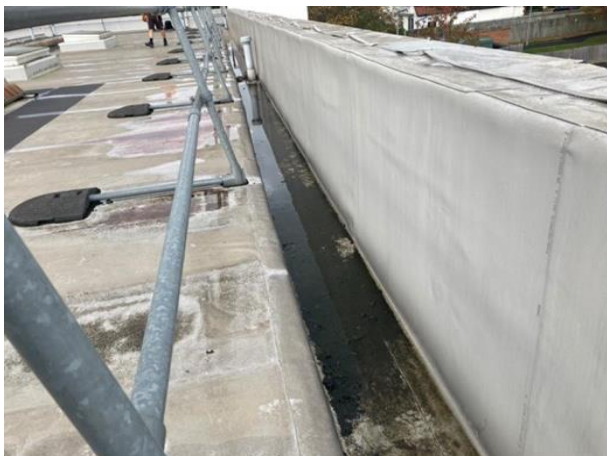
**Overview of gutter with ponding inside**

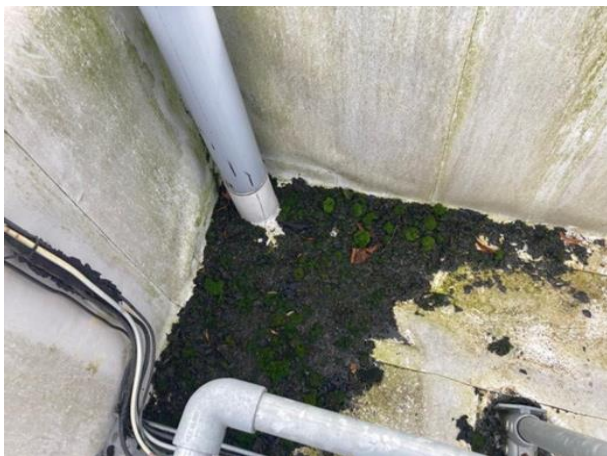
**Moss growth**

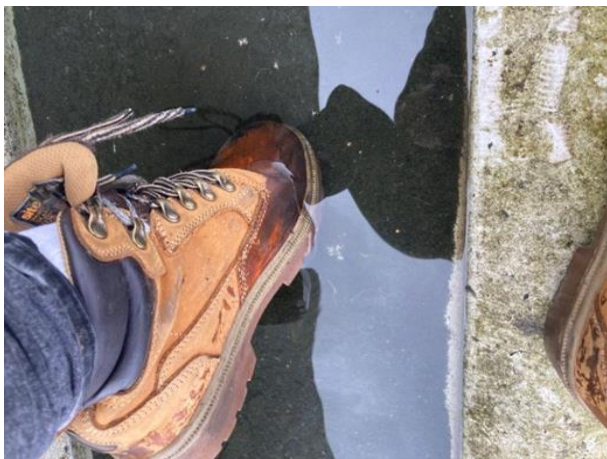
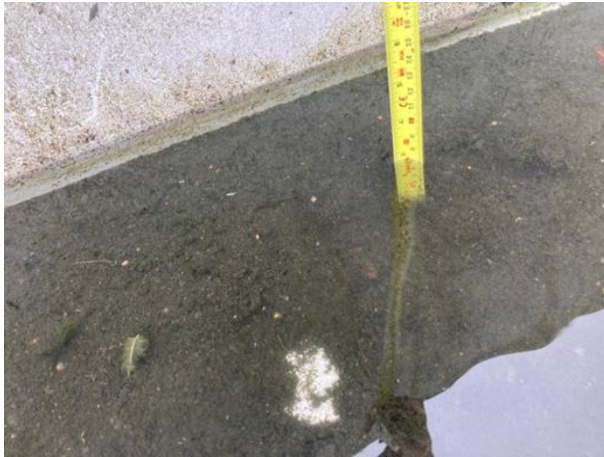
**Further evidence of major ponding inside the gutter.**
