## SUMMARY OF MAINTENANCE ACTIVITY SINCE THE PREVIOUS MEETING

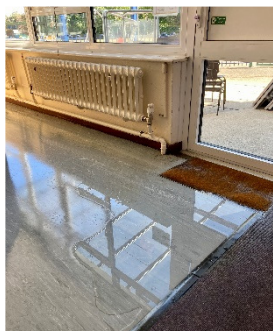
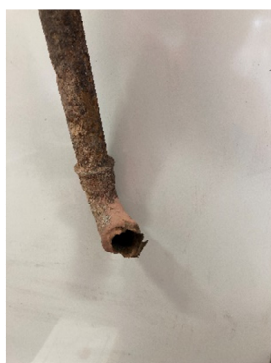
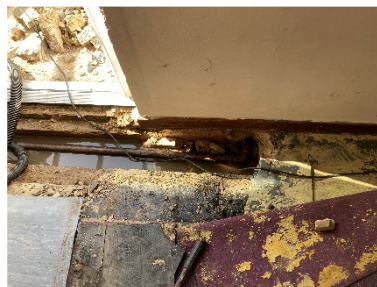
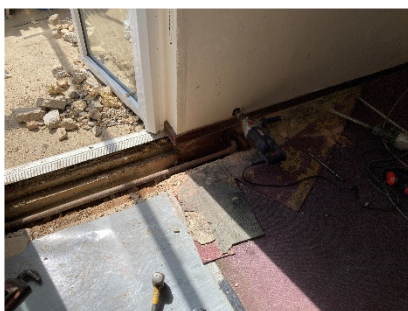
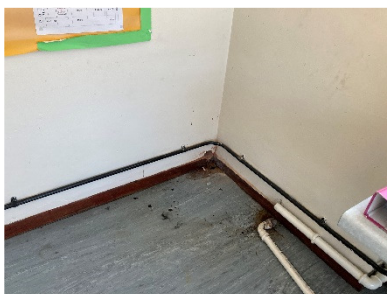
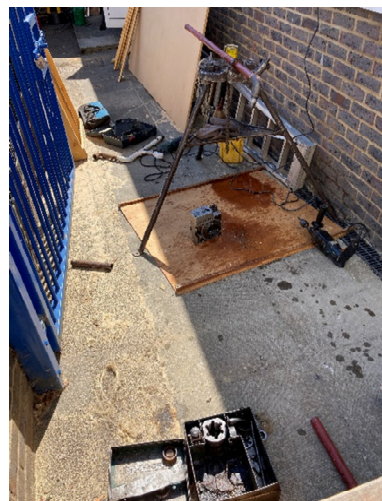
#### Burst Pipe:

Water was found seeping through the floor of the Butterfly Room. The Floor was dug up to reveal one of the original heating system pipes had corroded and failed. R+L Paul removed the corroded section and made up a replacement. It's likely the leak was long standing as we knew that the upstairs radiators required regular bleeding but it was concealed underground. A new pipe was fitted through the 15-inch-thick wall. We still have air in the system so there is likely to be another section of pipe underground that is leaking but we must wait for the heating to be switched so we can use an infrared heat detector to locate it.

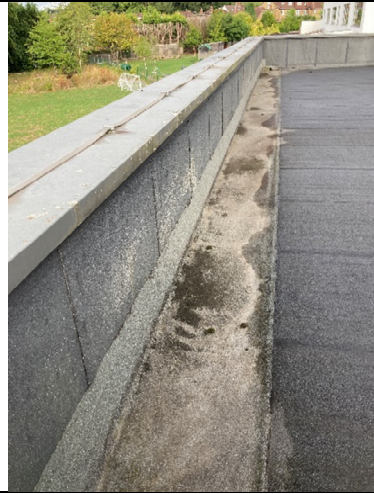
#### Hall Roof Leaking:

Water was found to be dripping from the ceiling of the hall. On checking the roof I found a 2m x 20m section of the felt has water trapped under it. As is it on the new build extension I contacted the Borough to confirm whether they hold liability for the repair as roof work usually carries a 10 year warranty and I am awaiting a response.

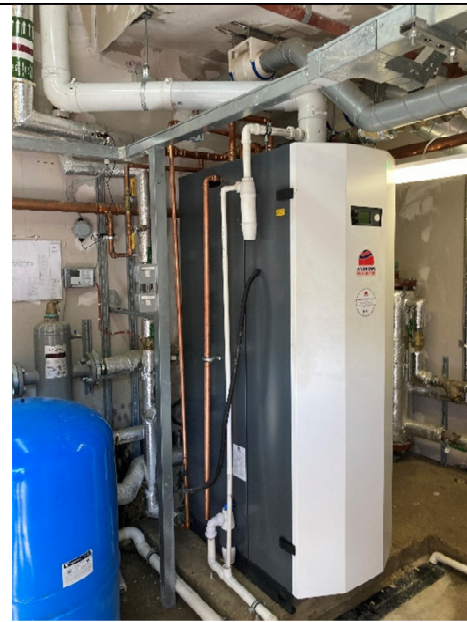
**Replacement hot water boiler for the West Block.** The boiler is larger than the original so a number of pipes had to be re-routed but it is far more accesible for servicing or repair as the front panel opens to reveal the entire workings.

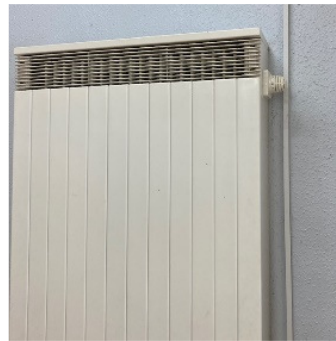
**Hall Radiators** fitted with thermostats with the controls out of reach of children.

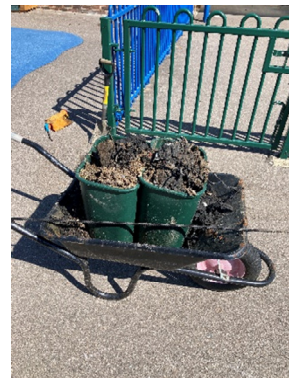
**Drains outside Nursery and Receptions classrooms cleared out**

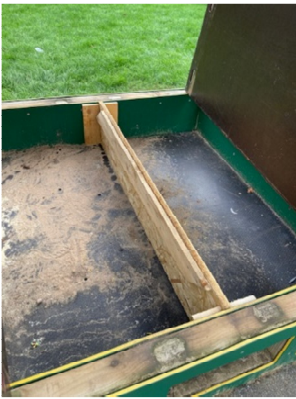
| <p><b>Removable Centre support fitted</b> for the reception playground “bandstand”. This allows children to safely stand on top and</p> | |
